# DSC Inspections LLC

Date of Inspection: 11/28/2005

Address of Inspection: 1234 Anystreet Ave , AnyCity, CA

Report Number: 20051128-DSC-1  
Inspection Type: Visual  
Total Fee: \$0.00  
Paid By: Check (#12345)

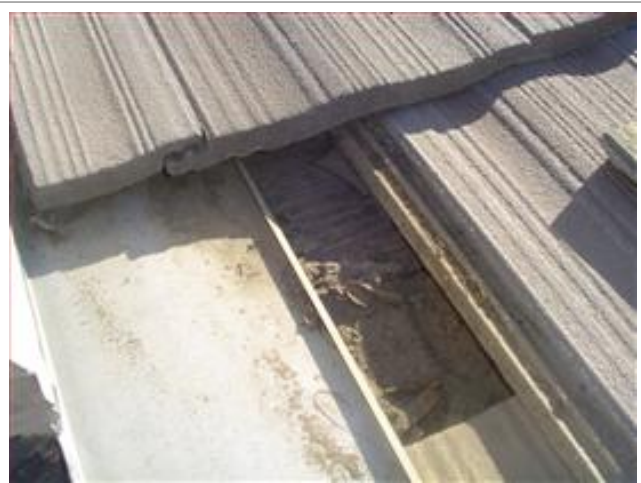
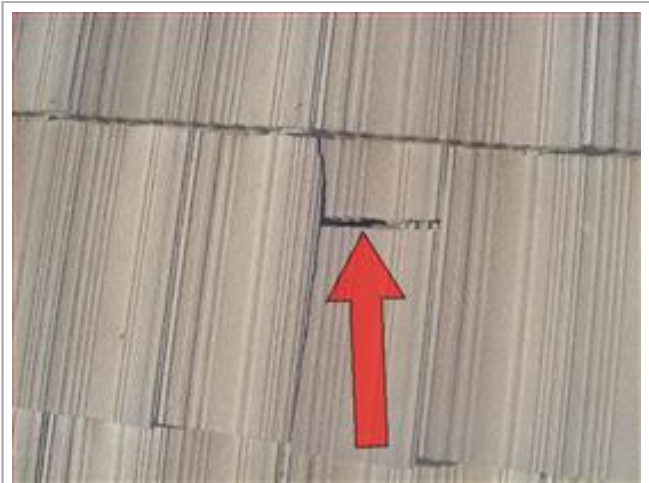
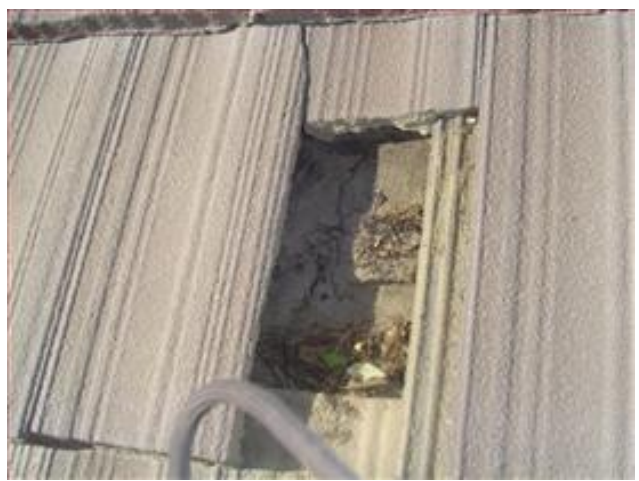
- There are several broken roof tiles that need to be replaced. Broken roof tiles allow excess water onto the felt underlayment, which can prematurely deteriorate the felt underlayment. Recommend a licensed roofing contractor evaluate conditions noted. (See Figure #1) (See Figure #2) (See Figure #3)

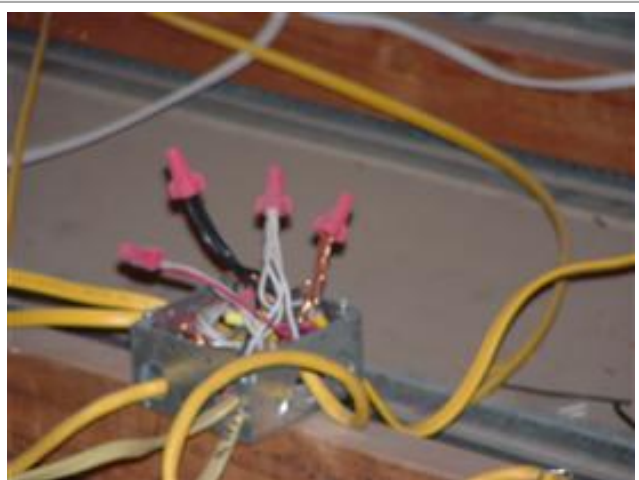
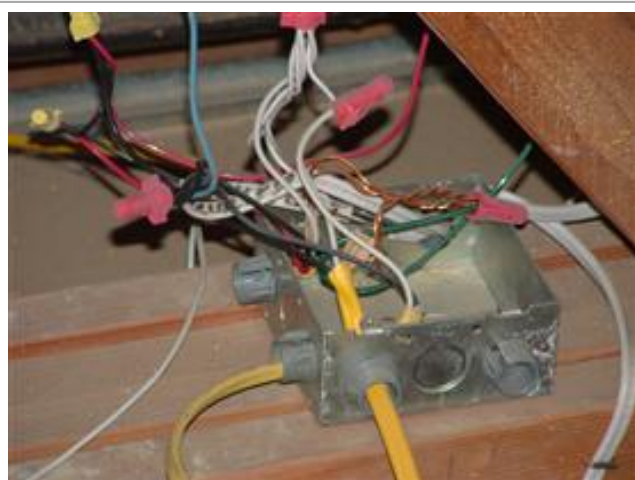
- There are several over stuffed electrical junction boxes in attic above garage. For safety, recommend evaluation by a licensed electrical contractor. (See Figure #5) (See Figure #6)
